SECON Airborne Survey Experience

First private company in India to conduct Aerial LiDAR Survey in India

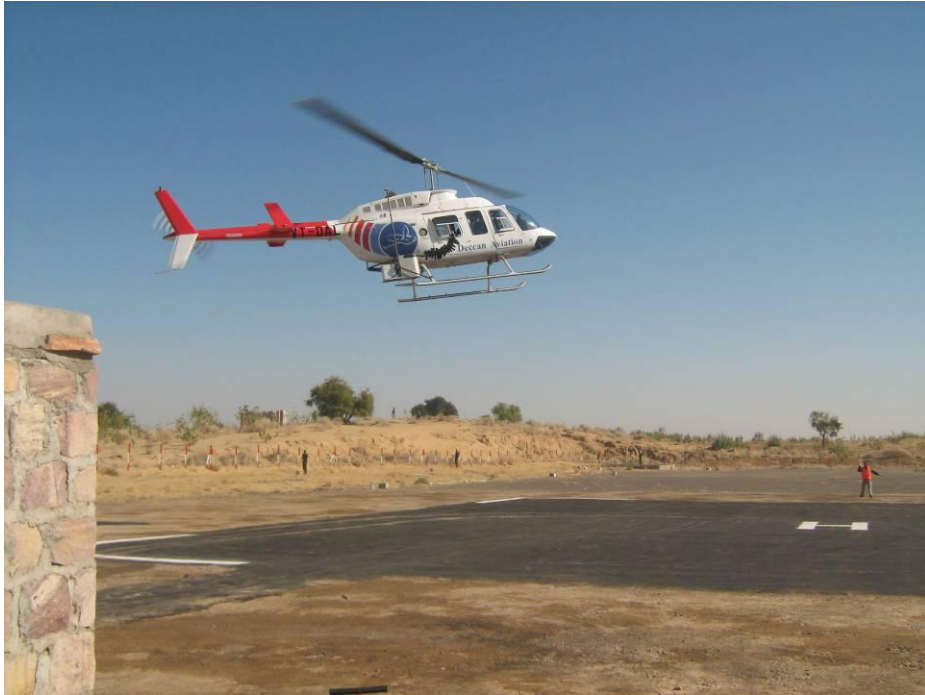
Helicopter with LiDAR Sensor taking off from Helipad for Mapping

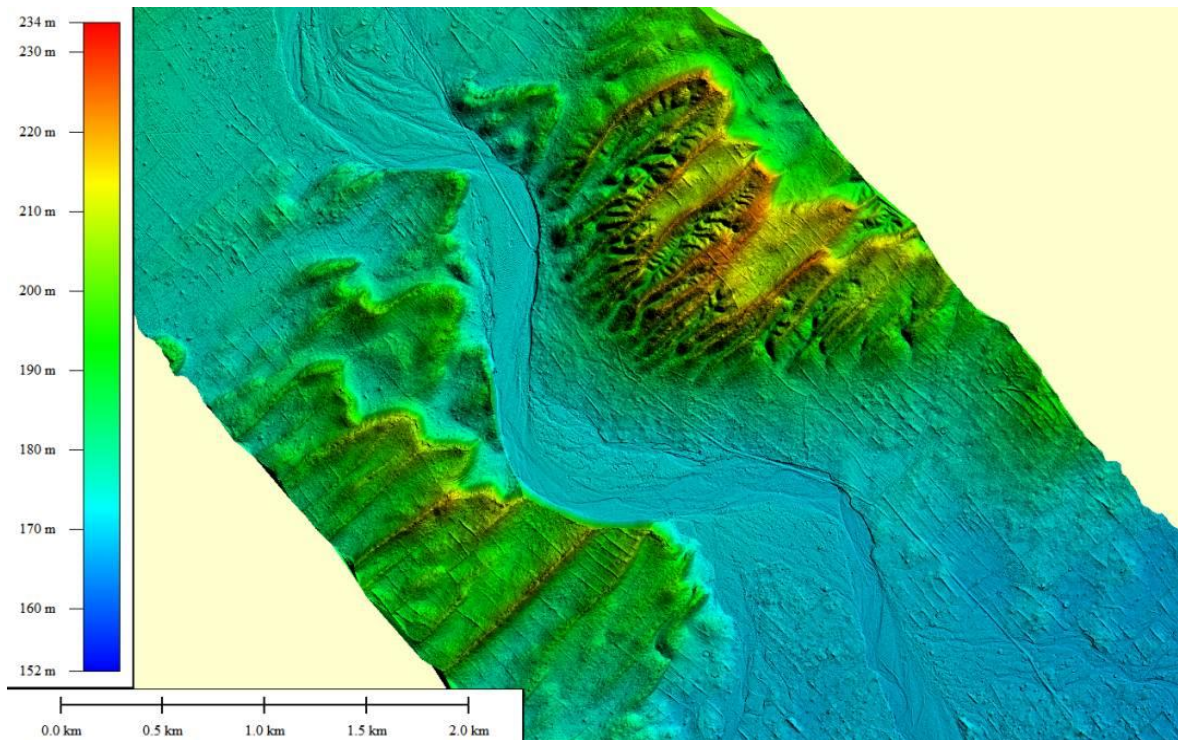
Aerial LiDAR flood model for real world simulation and analysis

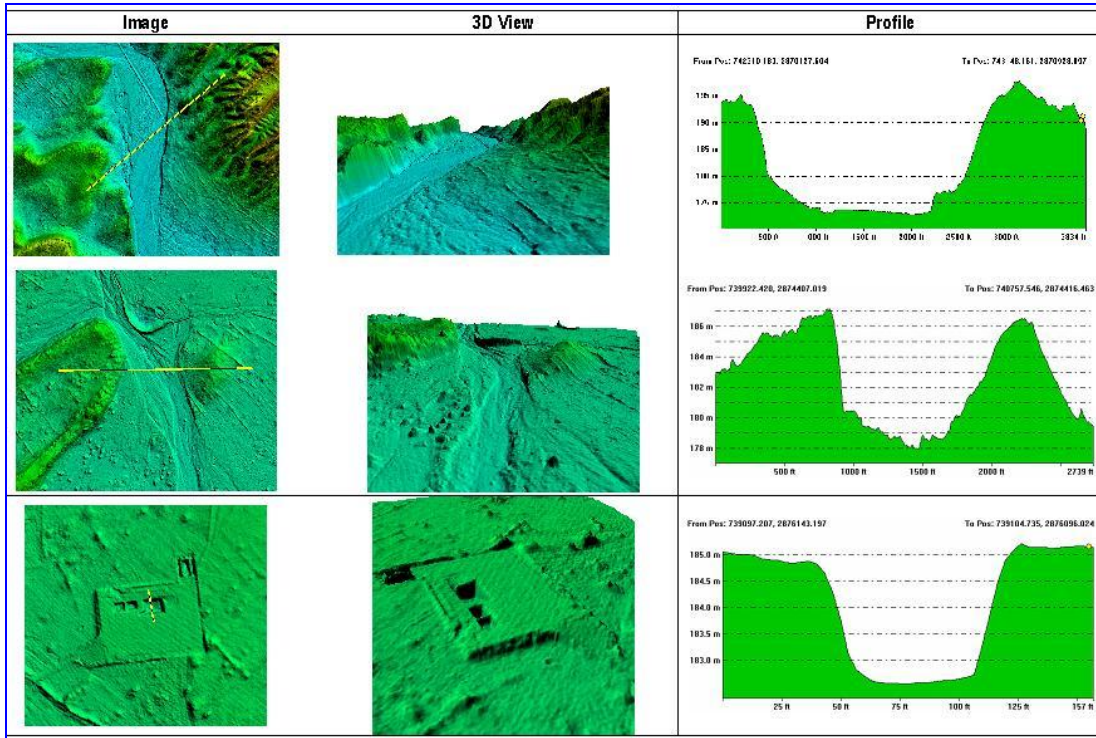
Cross sections from LiDAR model used for analysis

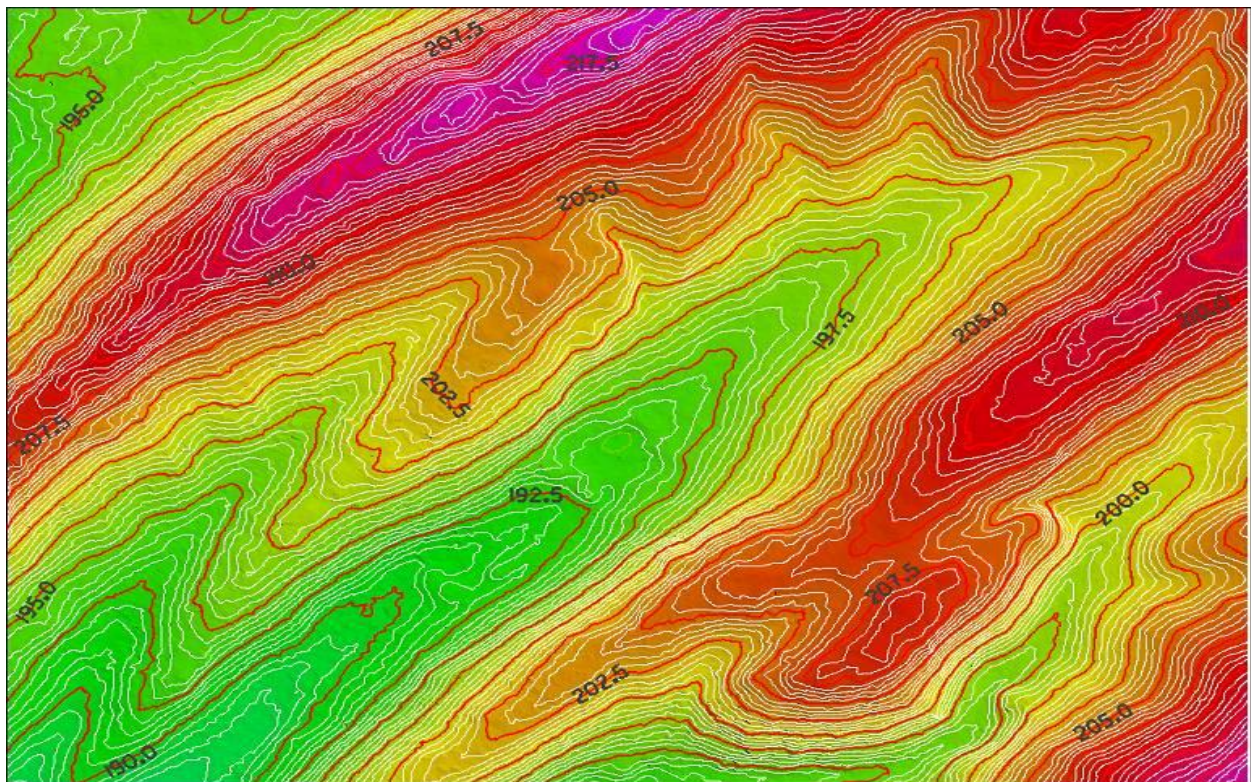
0.25m Contour Generated for the purpose of engineering analysis
